AGA KHAN DEVELOPMENT NETWORK
QUTB SHAHI HERITAGE PARK
CONSERVATION & LANDSCAPE RESTORATION

2017-18
ANNUAL REPORT

Qutb Shahi Heritage Park

Conservation & Landscape Restoration

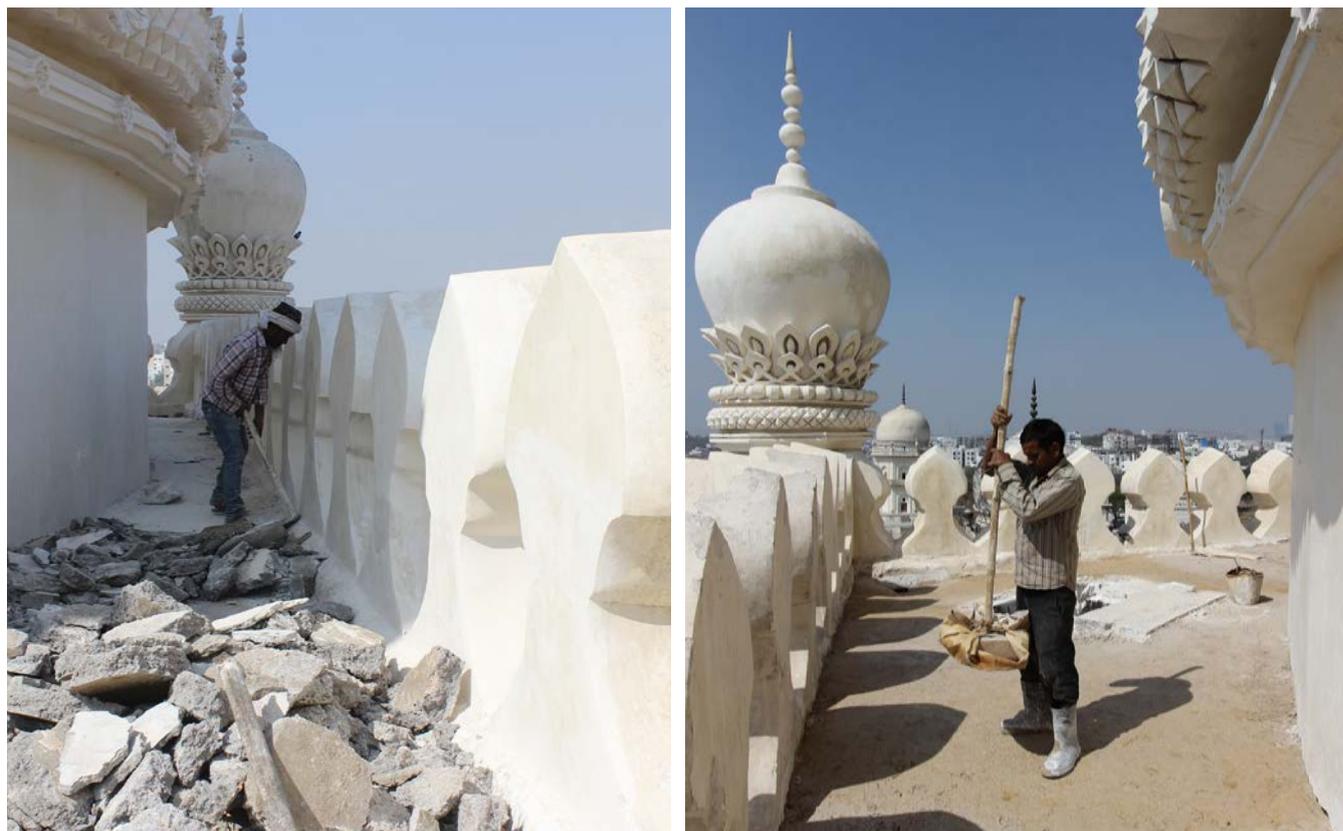
Removal of 20th century cement layers from the roof of the mausoleum

The cement from the roof was replaced with traditional lime mortar

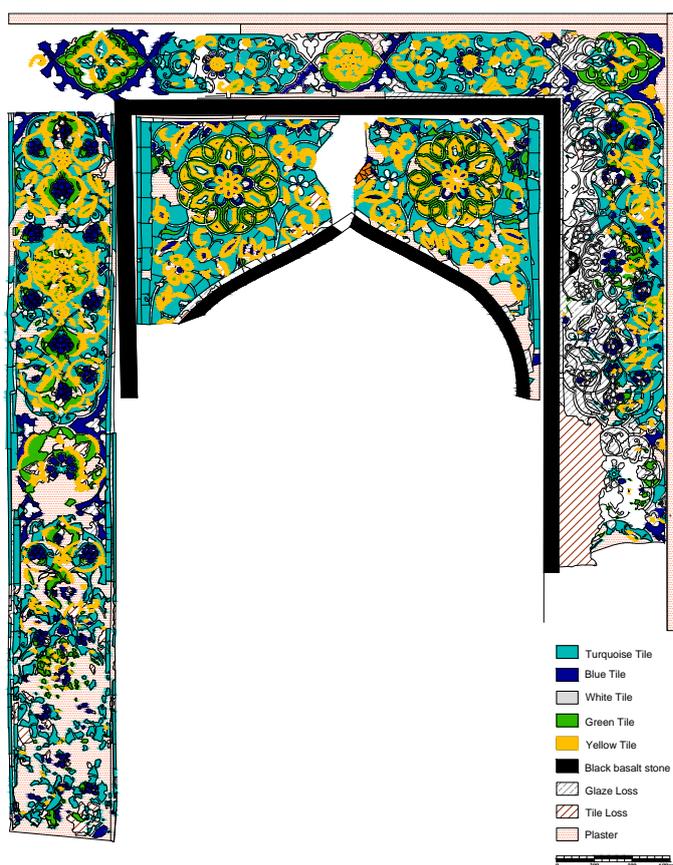
Architectural documentation of the tile work on the southern facade of the Ibrahim Quli Qutb Shah's Mausoleum

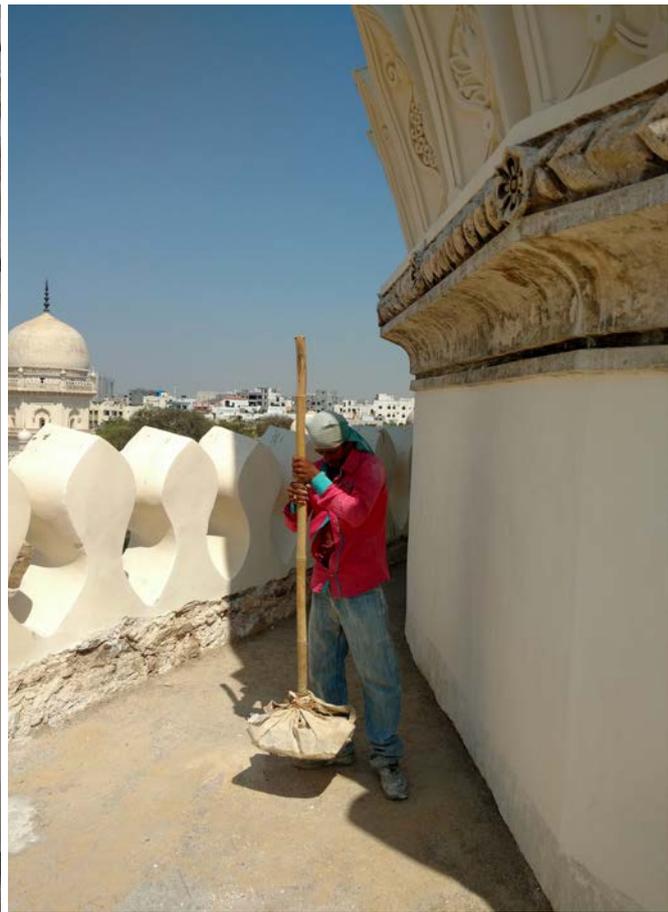
The cement from the terrace was replaced with traditional lime concrete

- On inspection, the terrace was found to be covered with a thick layer of 20th-century cement concrete and dilapidated lime concrete found below had developed cracks at multiple spots with rainwater seeping through.

- At the onset, vegetation was scientifically removed from the terrace cracks.
- The excess layer of cement concrete, which weighed around 30 tonnes was dismantled and debris cleared from the site.

- Base masonry of parapet walls on all four sides was repaired using rich lime mortar.
- 4 inch thick layer of traditional lime concrete was laid in appropriate slope, followed by continuous compaction and curing using traditional construction technology and techniques.

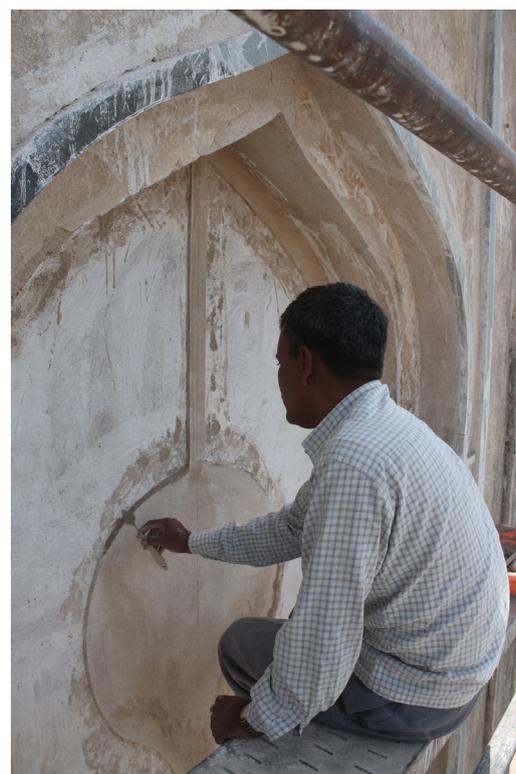
(Top) Outline of the missing detail on the facade were restored; (Middle) Missing stone elements added to the external blind arches on the facade; (Bottom) Physical documentation of existing tiles by architects

- Based on careful investigations and comparative analysis with the archival images, the outline of the missing patterns in the recessed portions of the arches at upper and lower tier were restored in rich lime mortar and finished with lime punning.

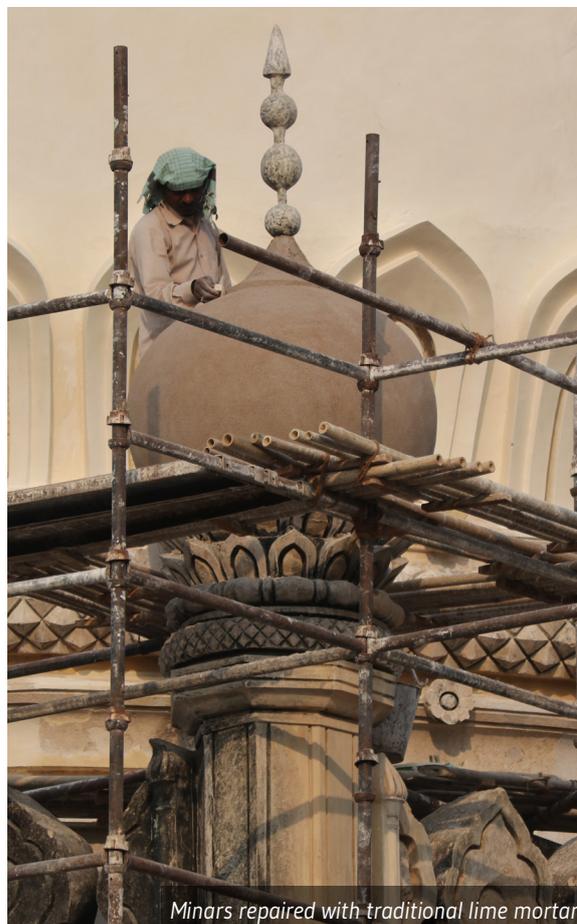
Minars repaired with traditional lime mortar

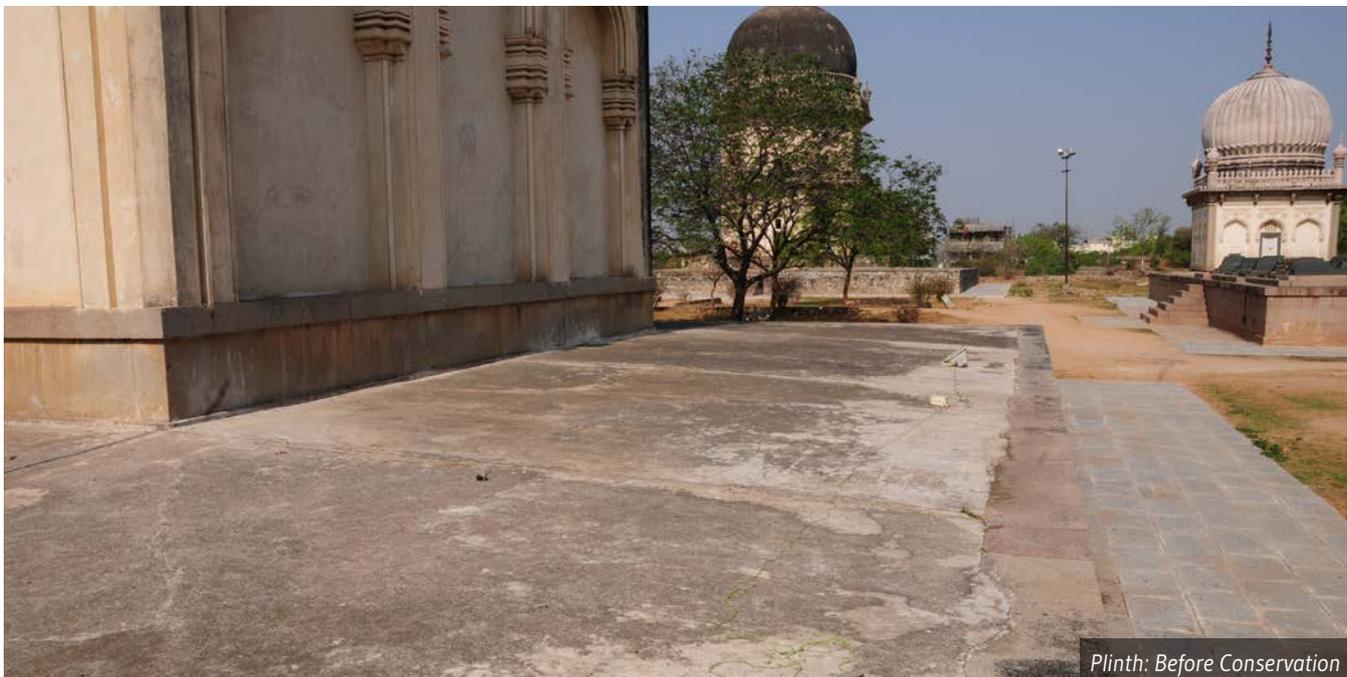
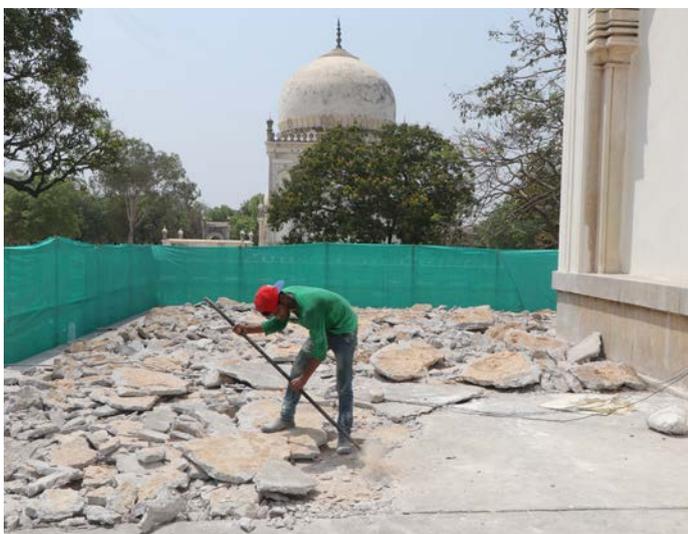
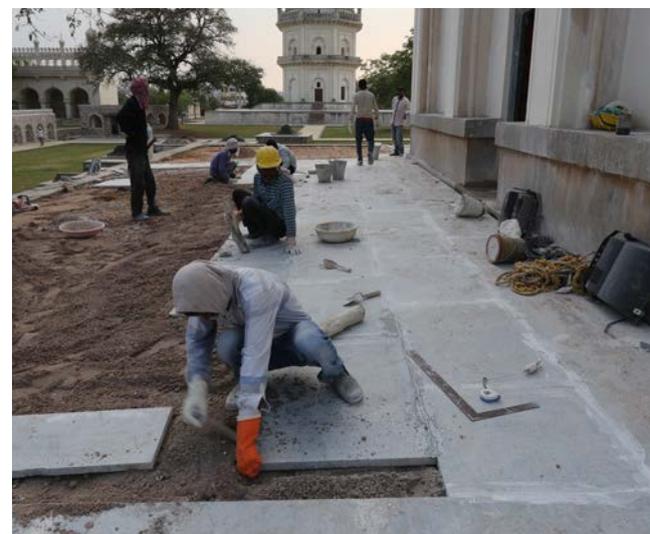
Removal of cement concrete from the plinth to halt further deterioration Laying of stone slabs on a layer of lime mortar to replace the cement

- Multiple edge stones lining the accentuated plinth were dislocated and re-instated to their original position.
- The plinth was found to be covered with a 20th century layer of 2-inch thick cement concrete. This layer was dismantled and the site cleared of debris.
- Installation of over 4000 square feet of 30 mm thick granite stone slabs in approved layout and appropriate slope was carried out to channel rainwater away from the mausoleum.

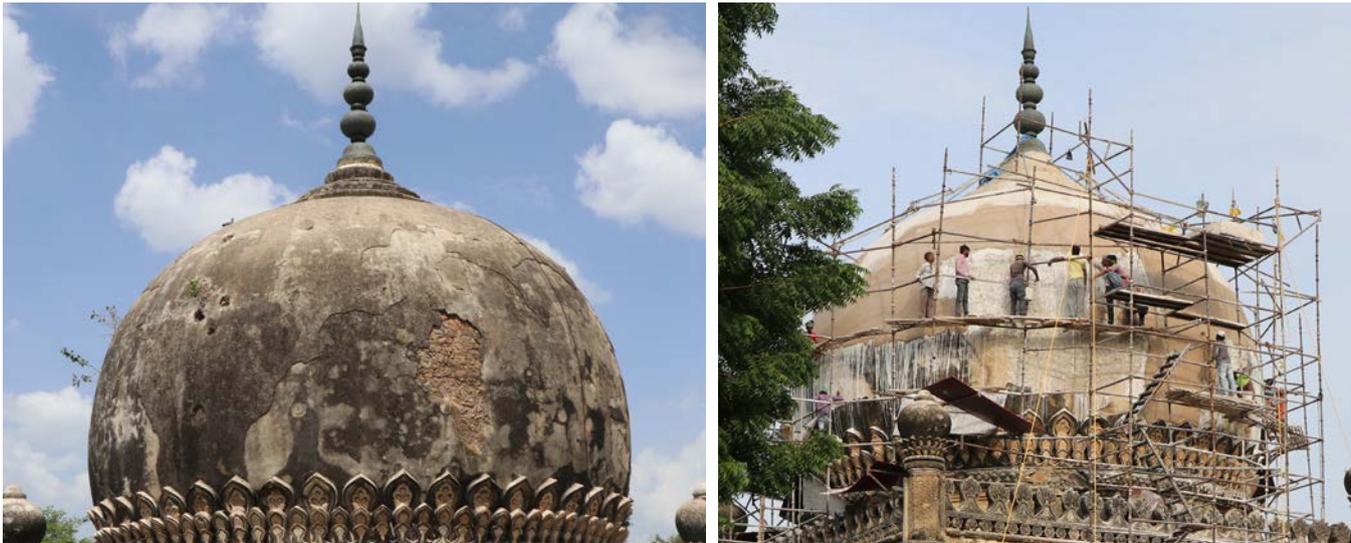
(Left) The dome of the mausoleum of Commander was covered with 20th century cement plaster which was causing damage; (Right) After careful removal of the cement layers, lime plaster was applied on the dome.

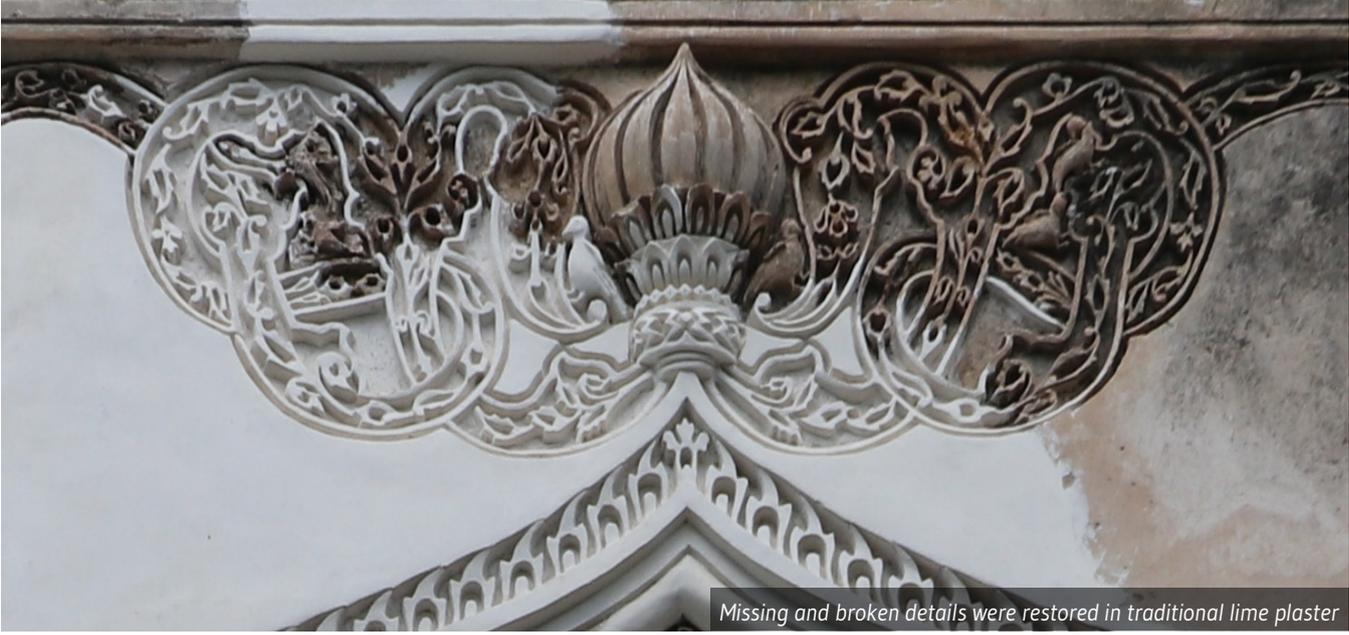
Missing and broken details were restored in traditional lime plaster

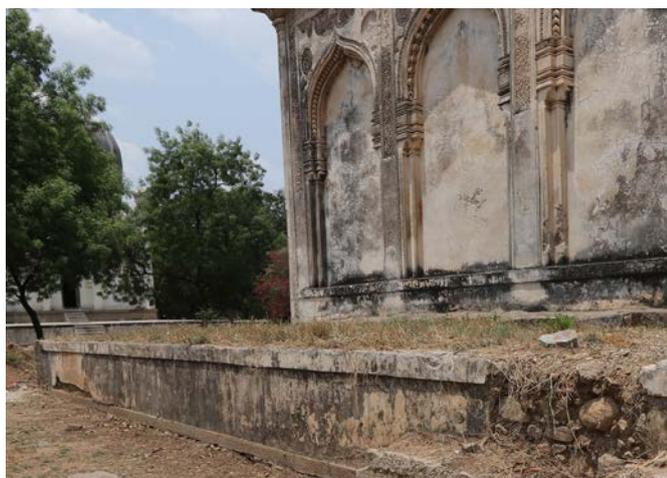
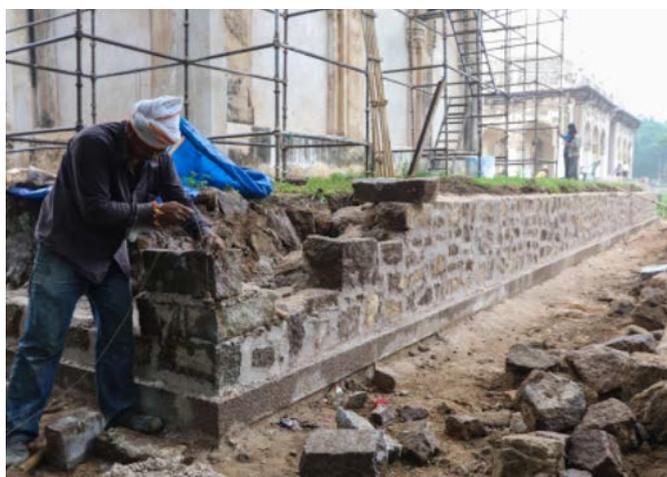
The plinth wall at Commander's mausoleum was bulging due to water ingress, was hence dismantled and followed by reconstruction with stone and lime mortar and installation of hand-chiseled stone coping

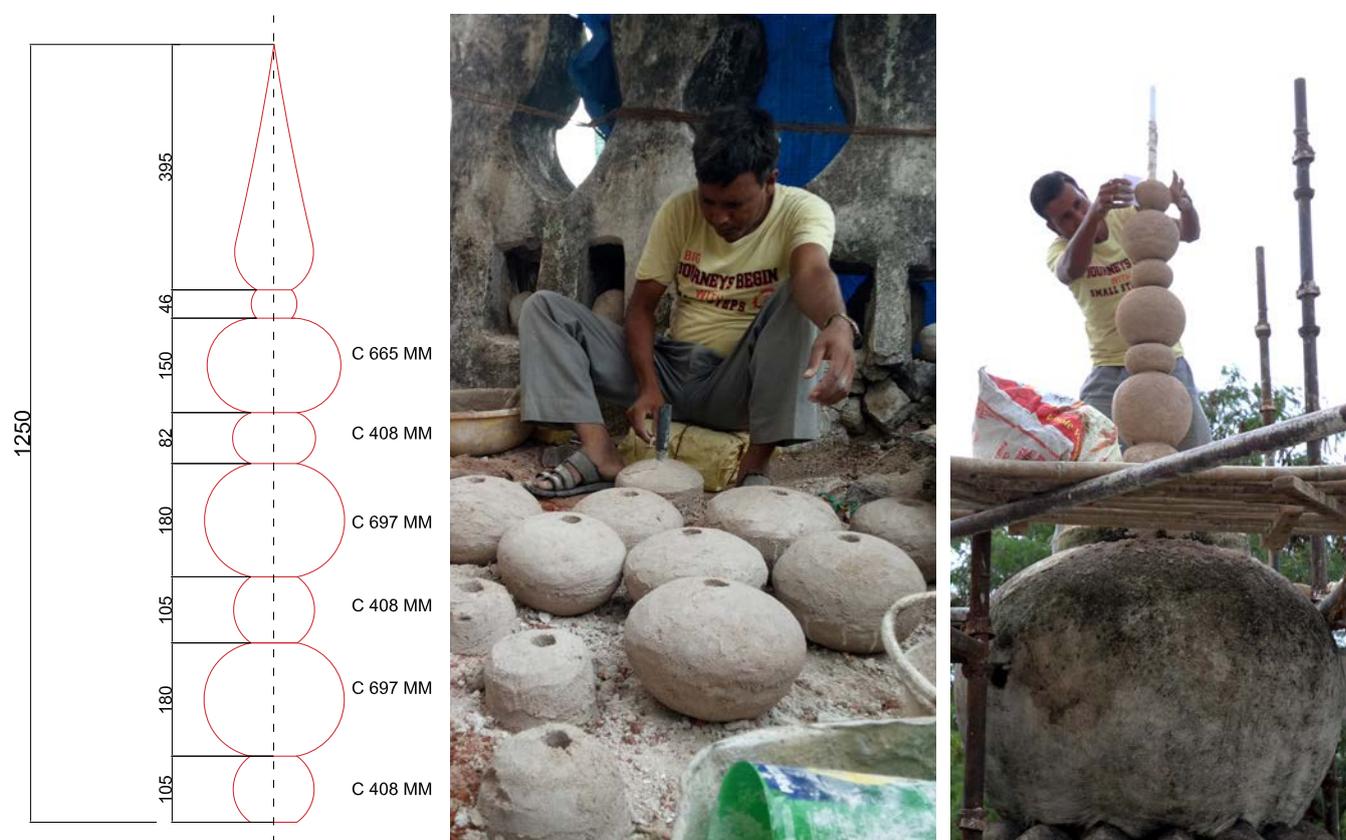
Missing finials on corner minarets were cast in lime mortar and installed in plumb matching the historic evidence.

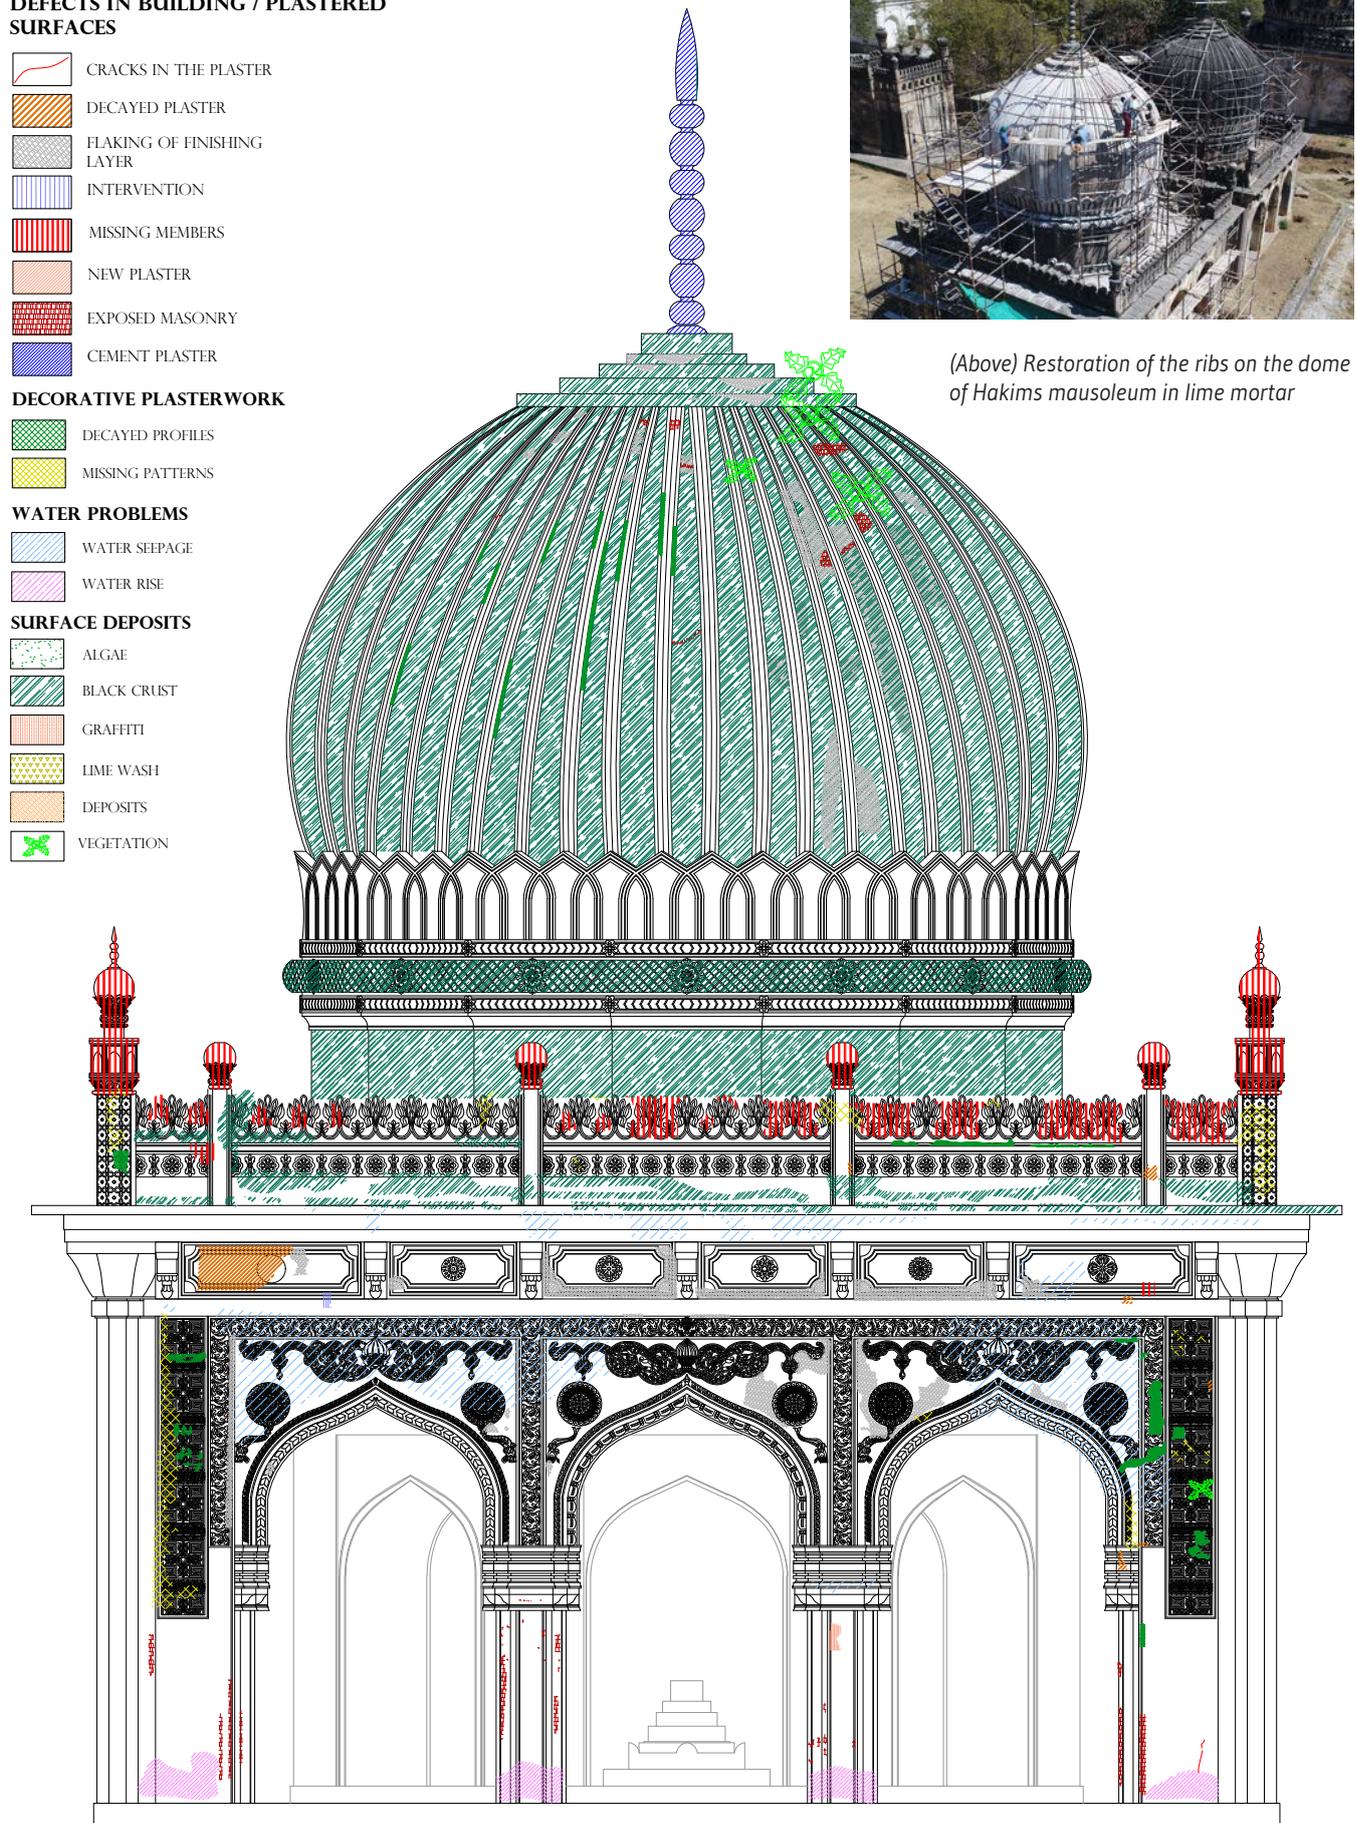
Detailed condition assessment of of the mausoleum situated to the west

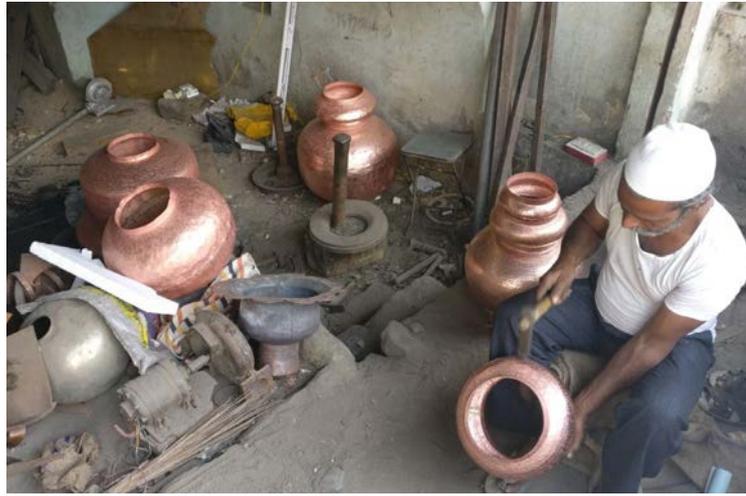
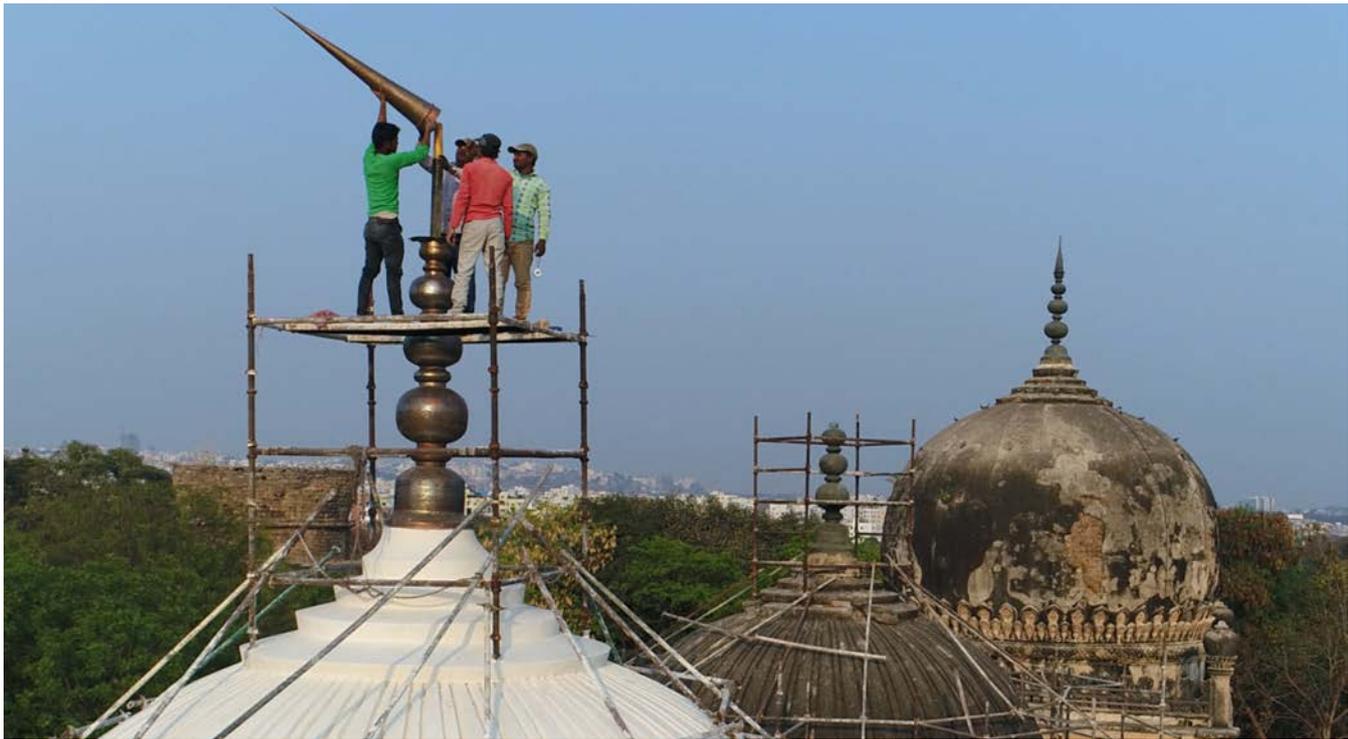
Installation of finial on the western dome of the twin mausoleums of Hakims'. (Top Left) Cement finial on the mausoleum to the west ; (Top Right) Local coppersmith fabricating components of copper finial; (Below) Installation of the finial on the dome

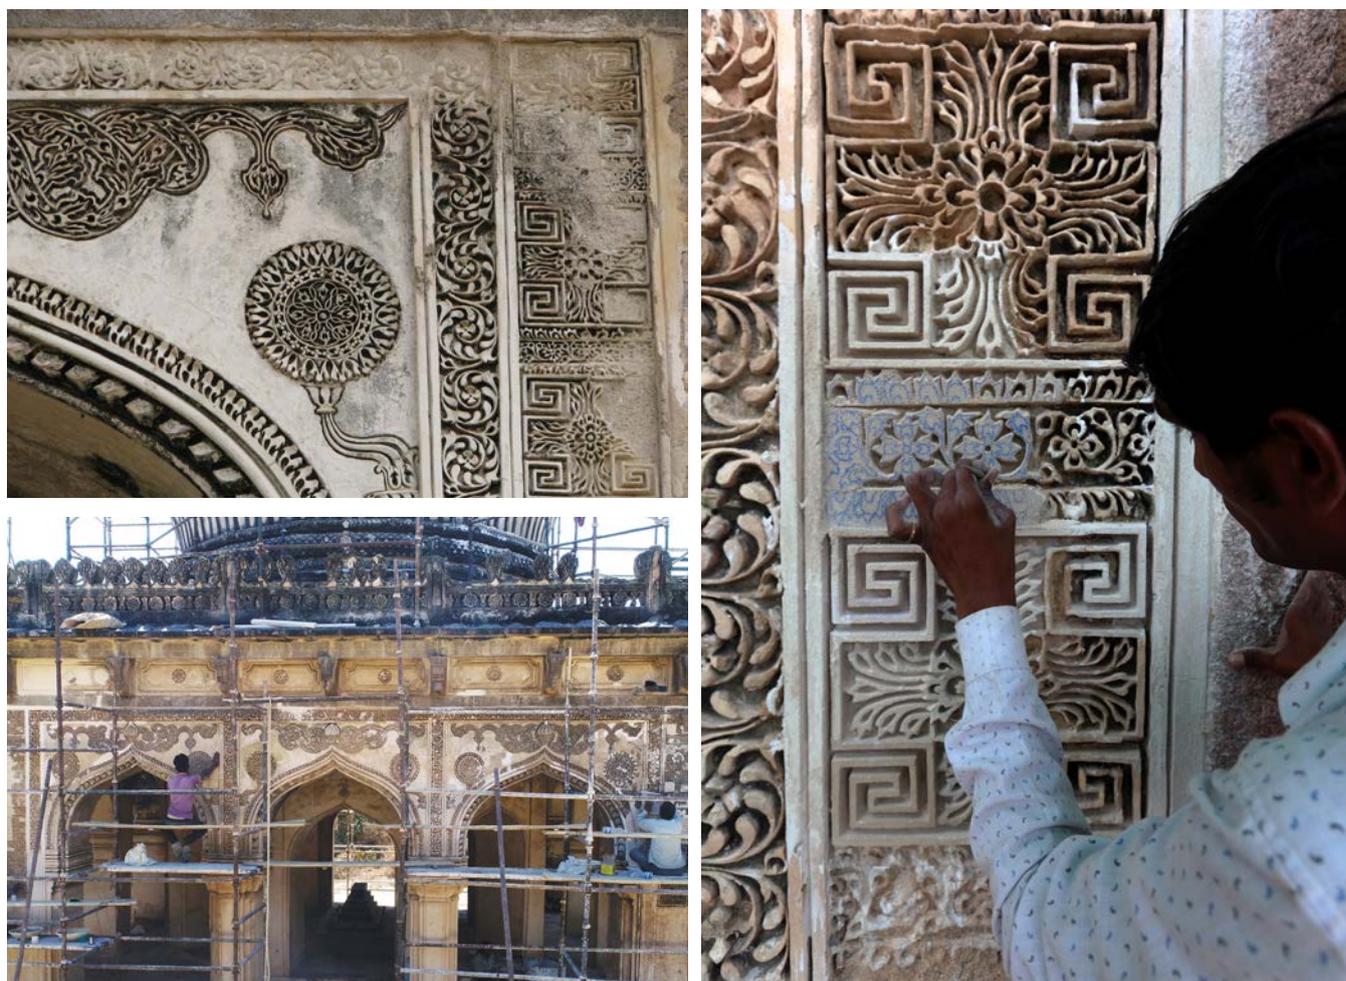
Missing and damaged ornate stucco patterns on the external facade of the twin mausoleums of Hakims' were carefully restored by craftsmen

- The facade on all the four sides of twin mausoleums was restored with highly ornate stucco plaster in form of floral-geometric and animate objects, medallions in the spandrels of the arches, arch crowns and moulding bands based on existing evidence, impressions that could be discerned by referring to archival images.

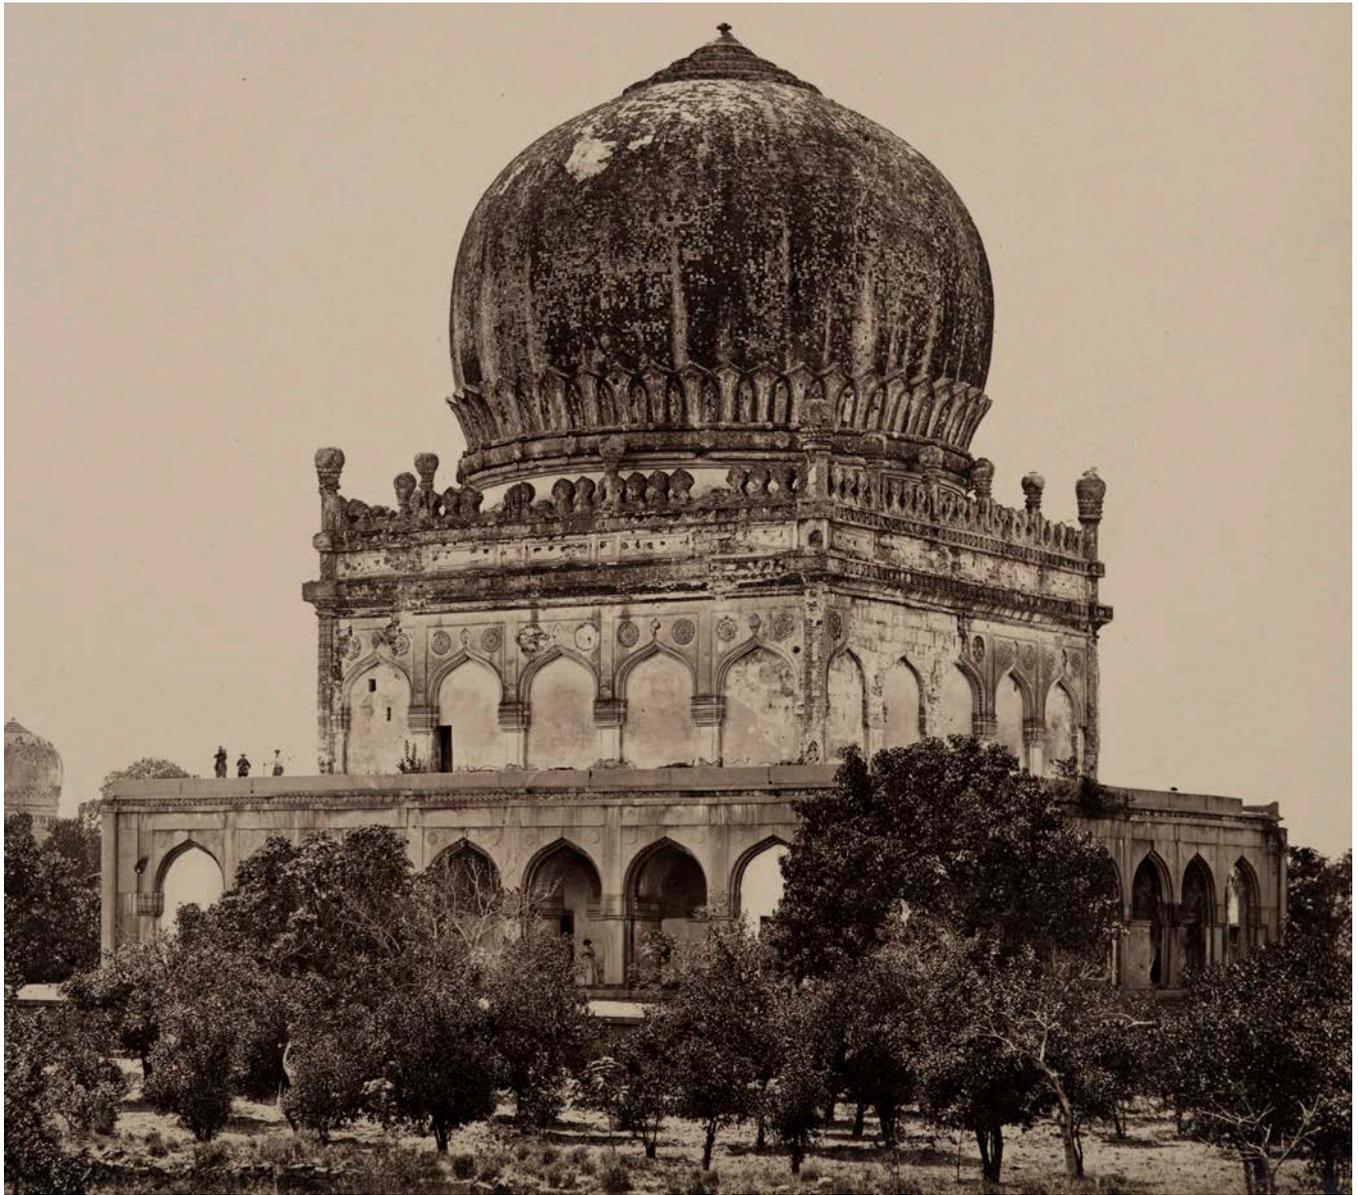
Archival image from the 1860s showing evidence of original tile patterns on the dome, merlons at the base of the dome, horizontal bands on the facade and the corner minarets. (Image source: Alkazi Foundation)

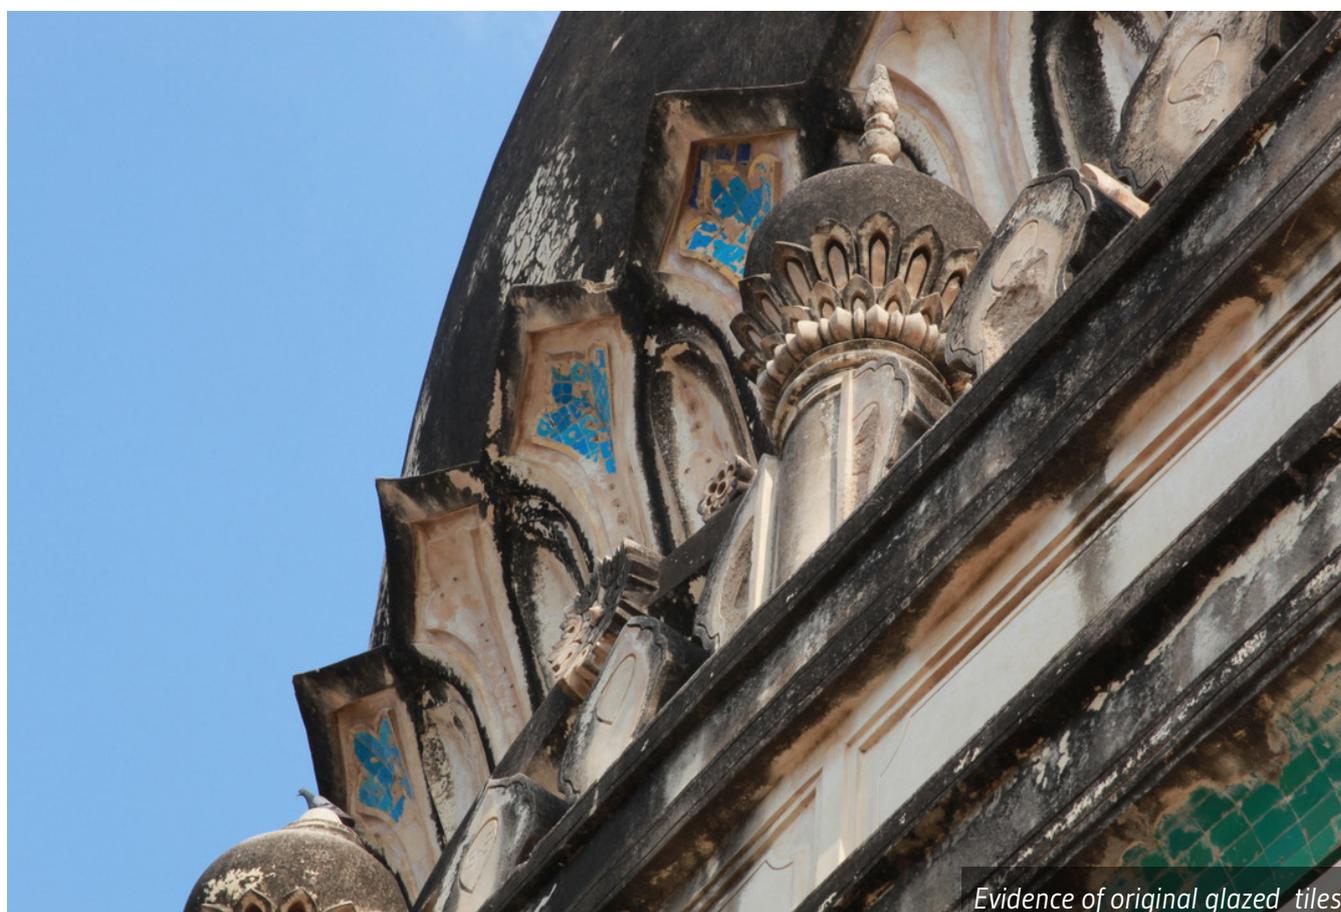
Evidence of original glazed tiles

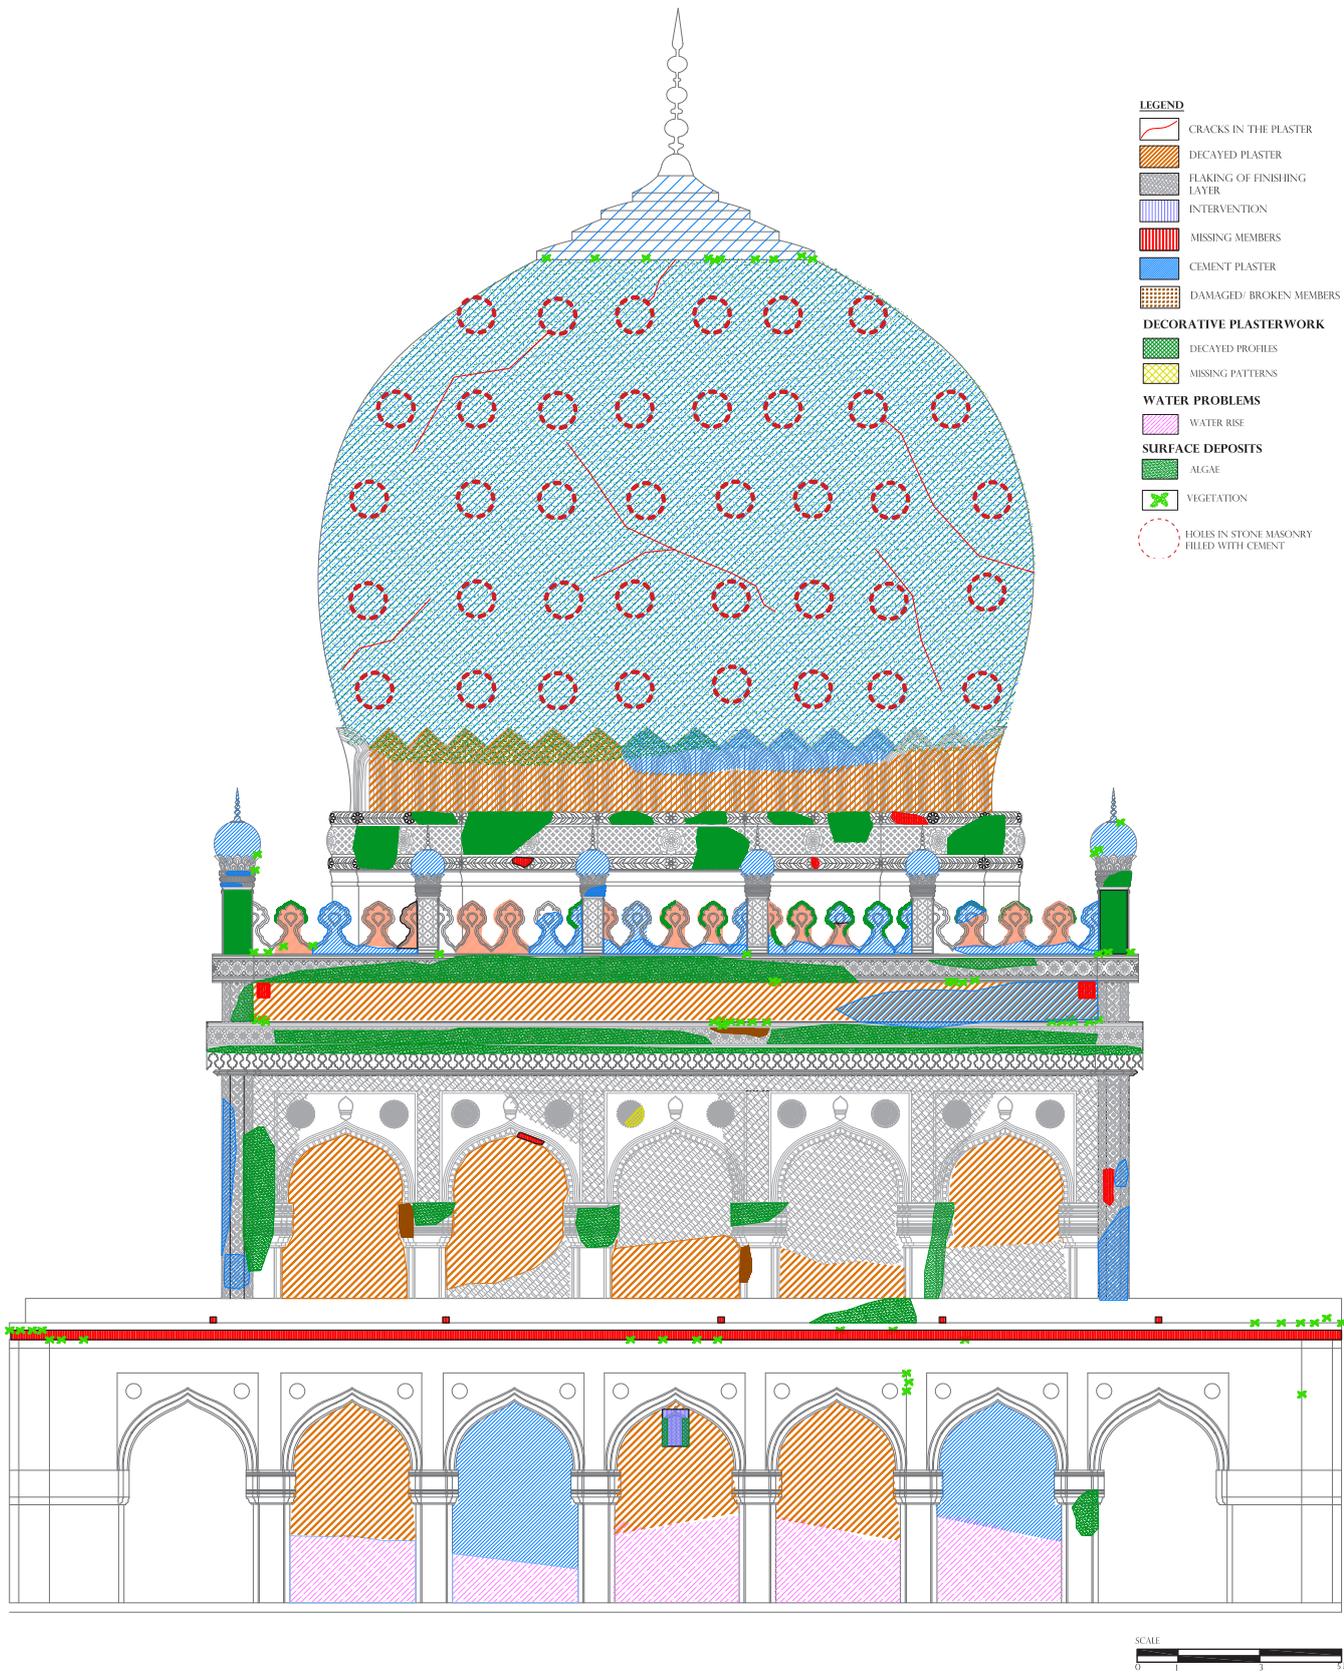
Conidition assesment of northern elevation of Hayat Bakshi Begum's mausoleum

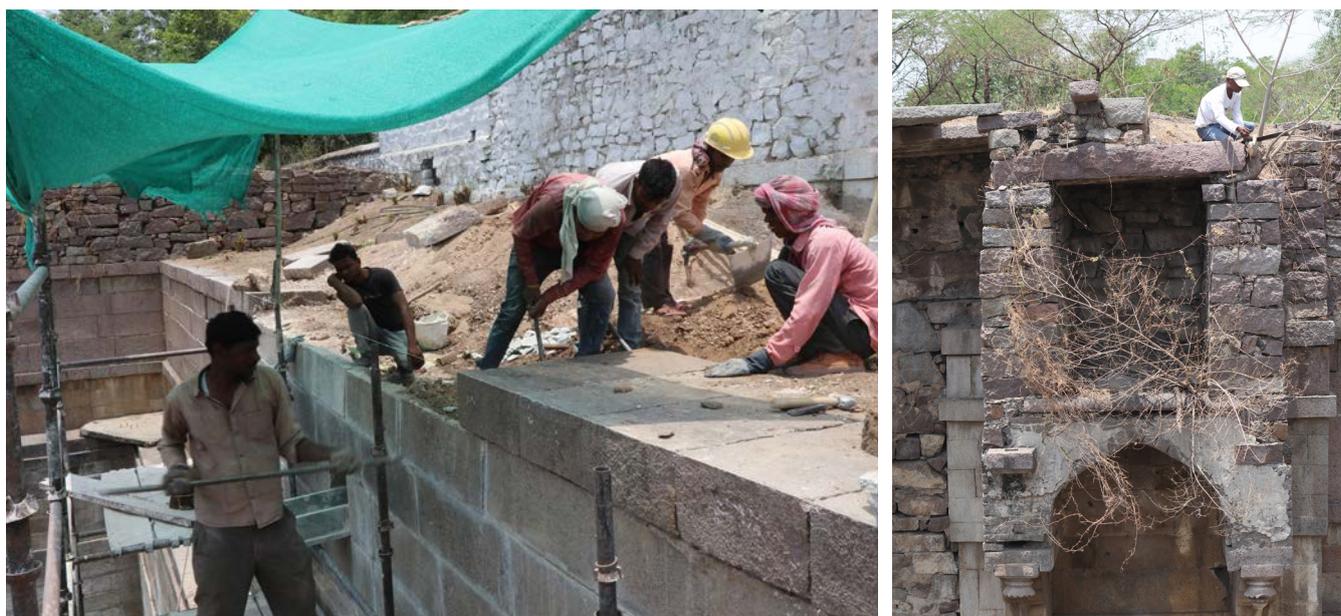
Due to lack of upkeep and periodic maintenance, baoli was in a dilapidated condition and number of stones were bulging from the wall line.

All the displaced dressed stones were realigned into place using the existing stones as reference *Thick tree roots were removed carefully to mitigate any further displacement and movement to the stones.*

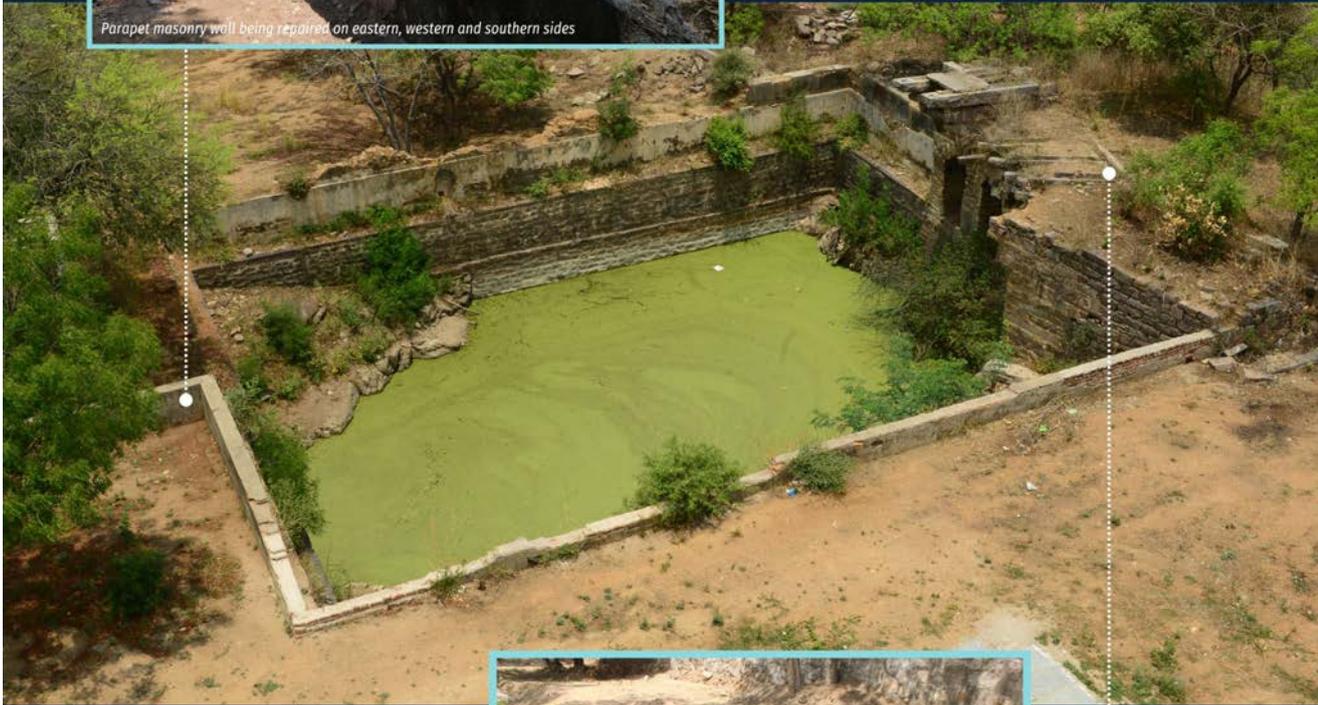
Channelization of rain water from adjoining areas into the Baoli

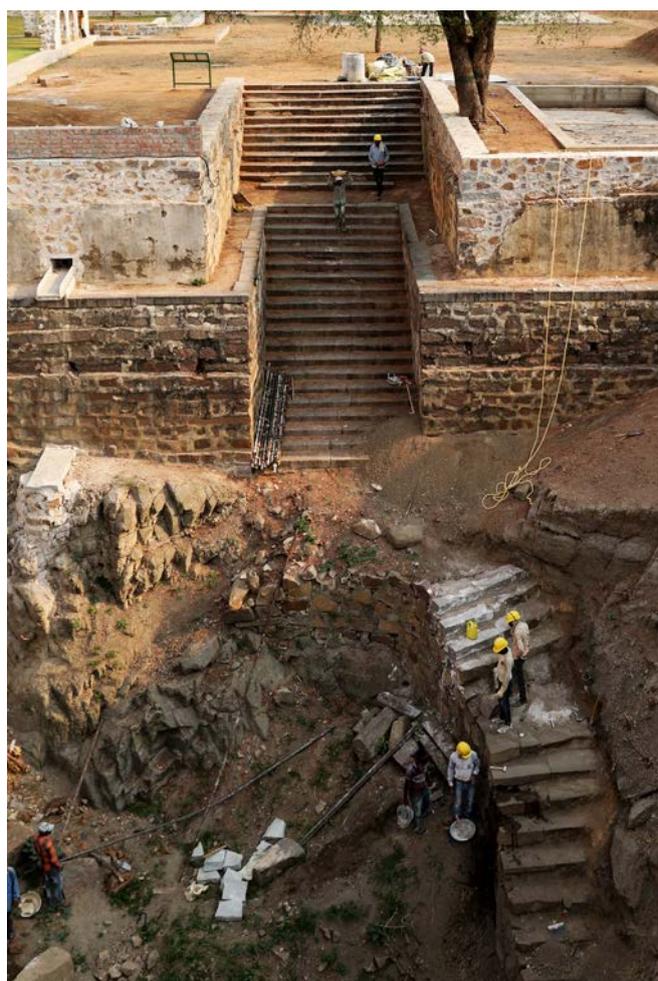
Repairs of the steps carried out, missing steps were reinstated

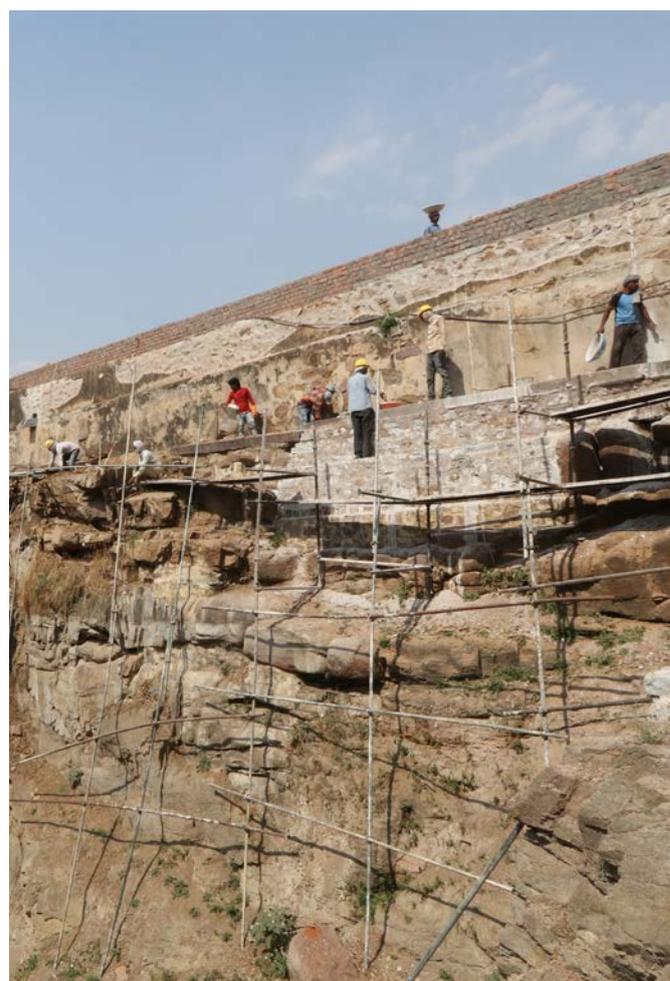
Missing hand dressed edging stones on the western and southern ledge of the baoli were installed
