AGA KHAN DEVELOPMENT NETWORK
QUTB SHAHI HERITAGE PARK
CONSERVATION & LANDSCAPE RESTORATION

2017-18
ANNUAL REPORT

Qutb Shahi Heritage Park

Conservation & Landscape Restoration

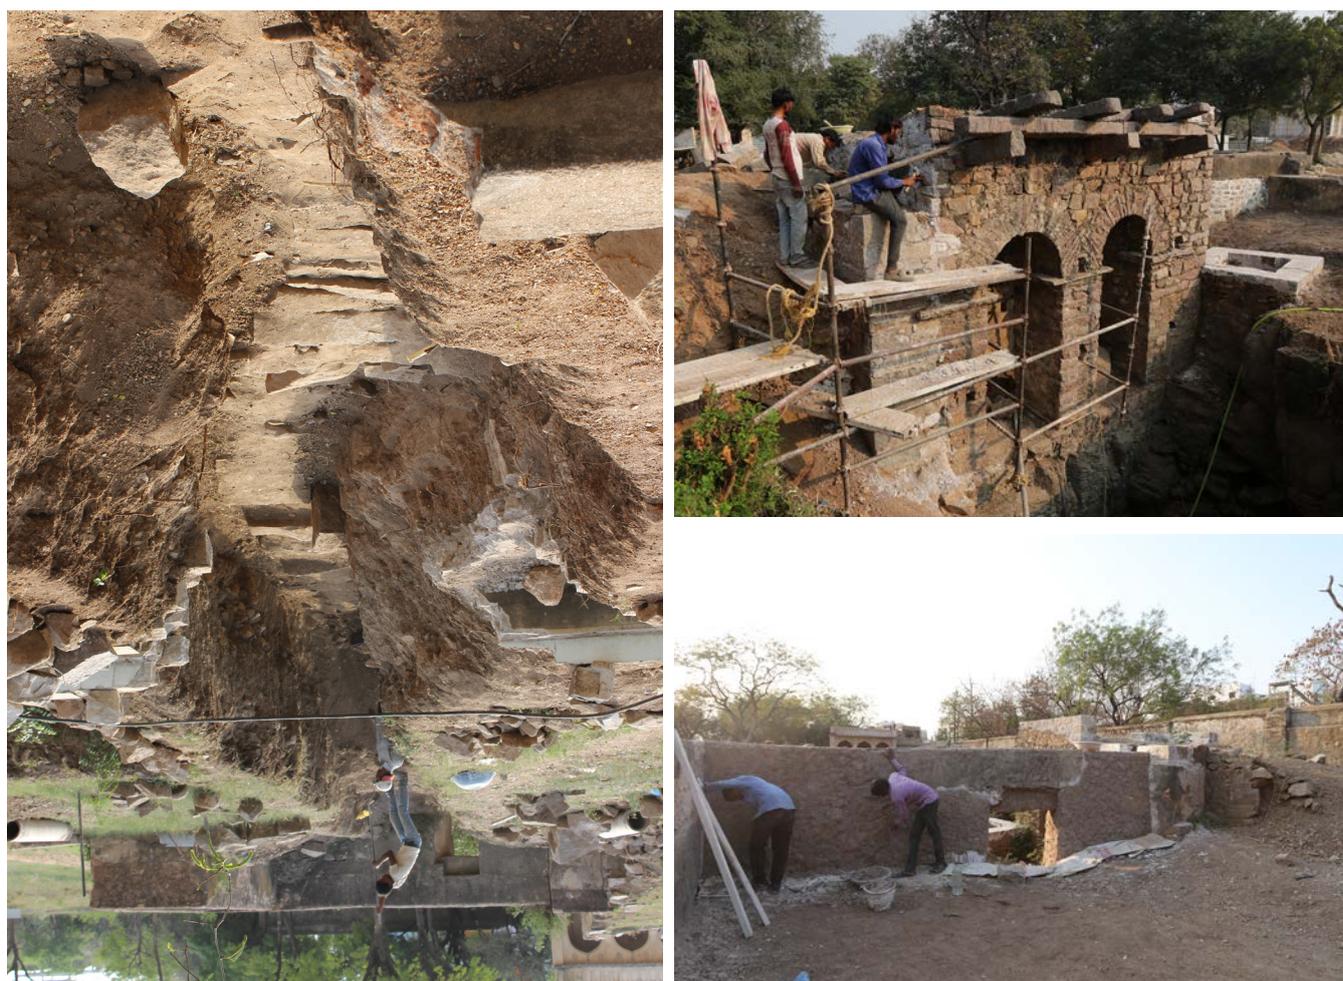
(Left) Aqueduct to the east of baoli; (Top right) Missing hand dressed edging stones on the western and southern ledge of the baoli were installed; (Bottom right) Low height brick parapet installed to prevent visitors from tripping inside the baoli

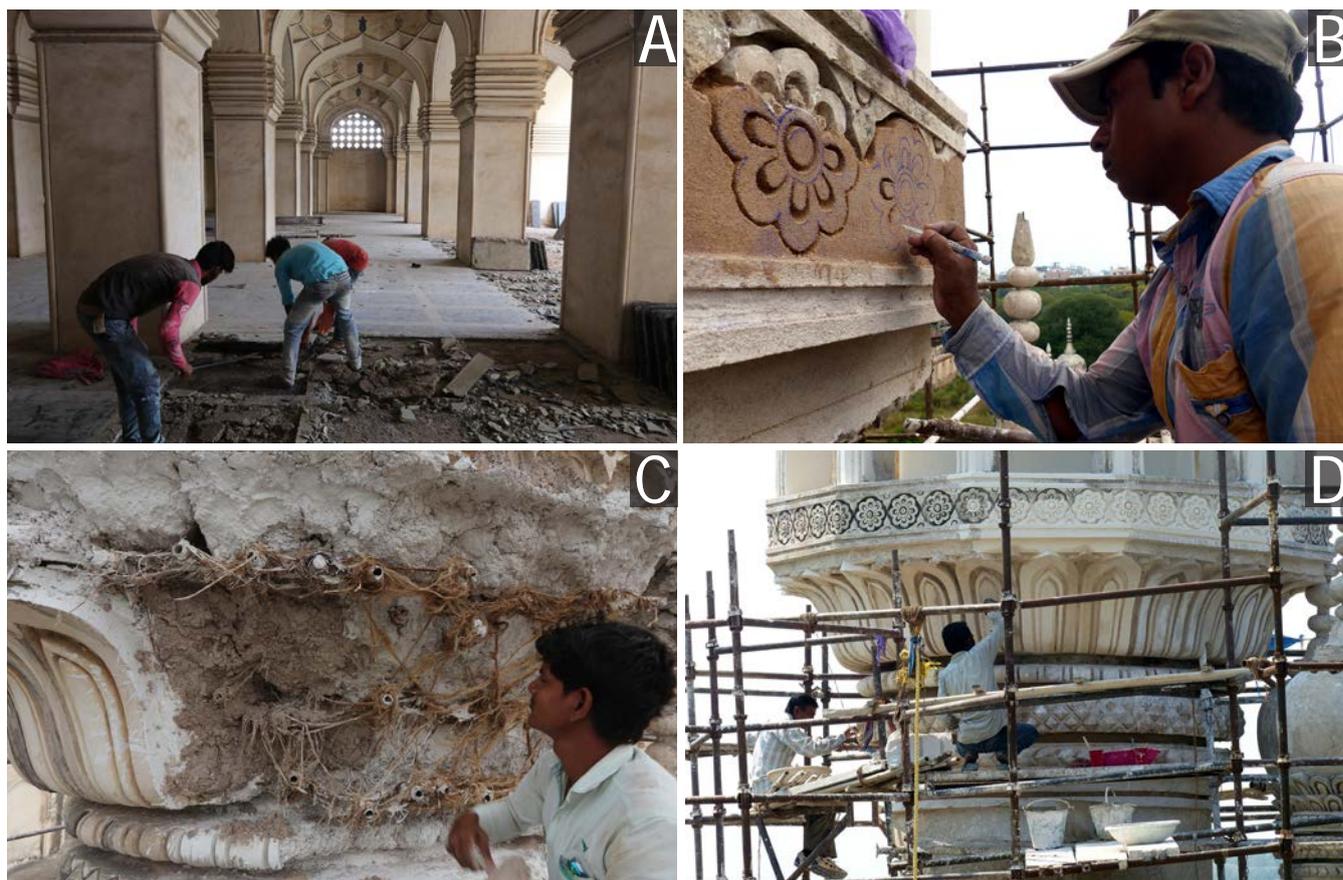
A: Dismantling of inappropriate 20th century stone flooring; B: Carving of floral medallions by lime craftsman ; C: Reinforcing damaged portion of minarets with jute fiber and lime mortar; D: Finishing of restored floral brackets supporting the arch gallery

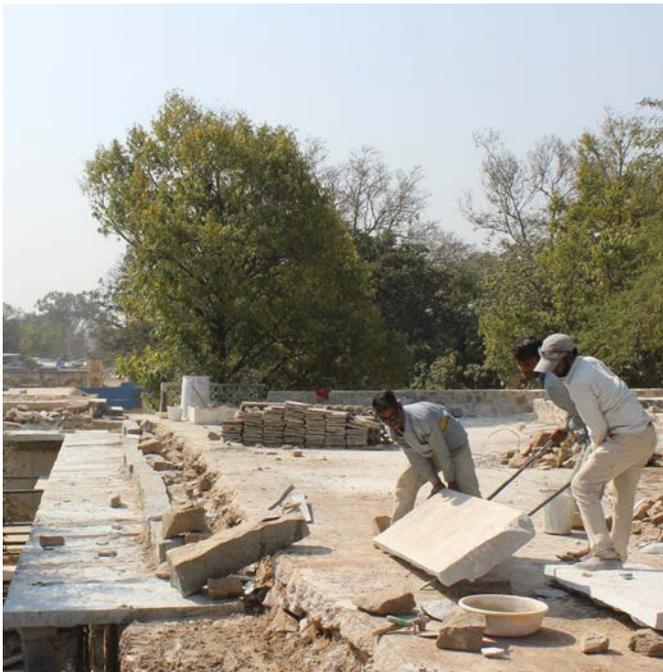
Stone eaves installed on the facade of serai

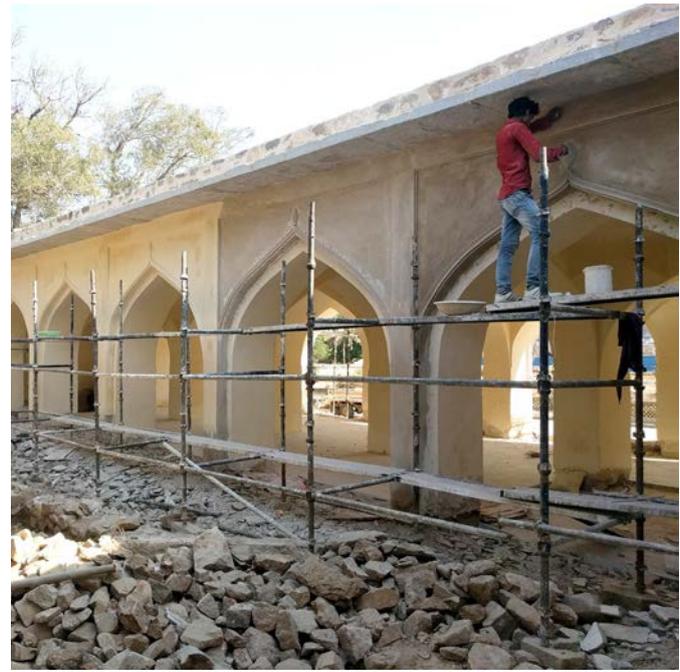
Repairs on the facade in lime after removal of 20th century cement layers

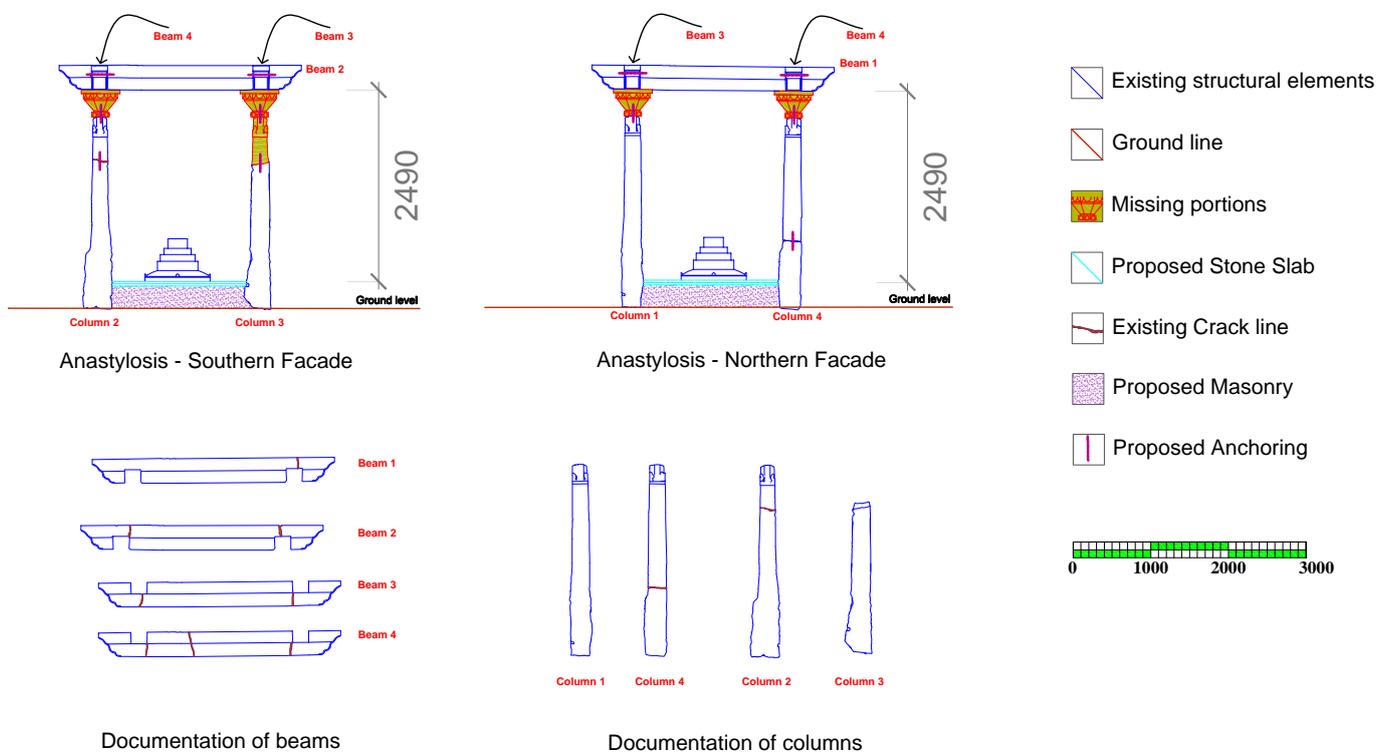
Detailed documentation of individual beams and columns marking the cracks for installation of stainless steel dowels for retrofitting

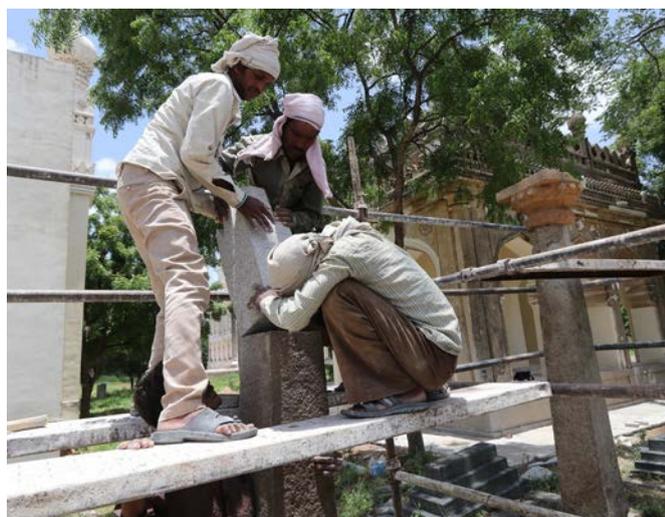
A hand carved stone piece of matching profile was retrofitted with stainless steel dowels along with epoxy resin

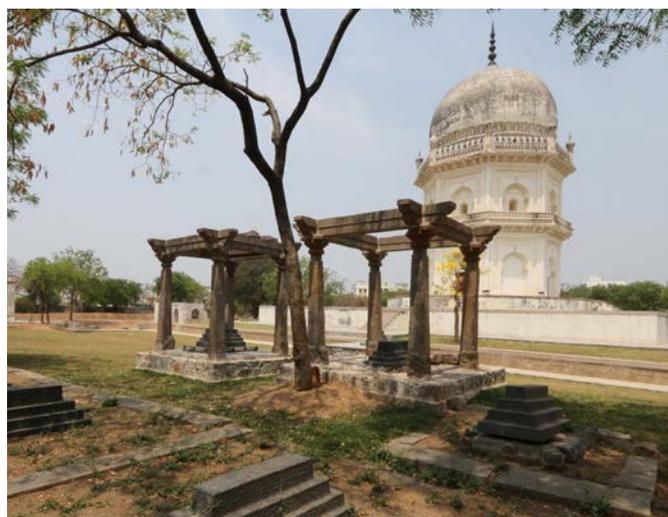
The collapsed pieces were reinstated in their original position

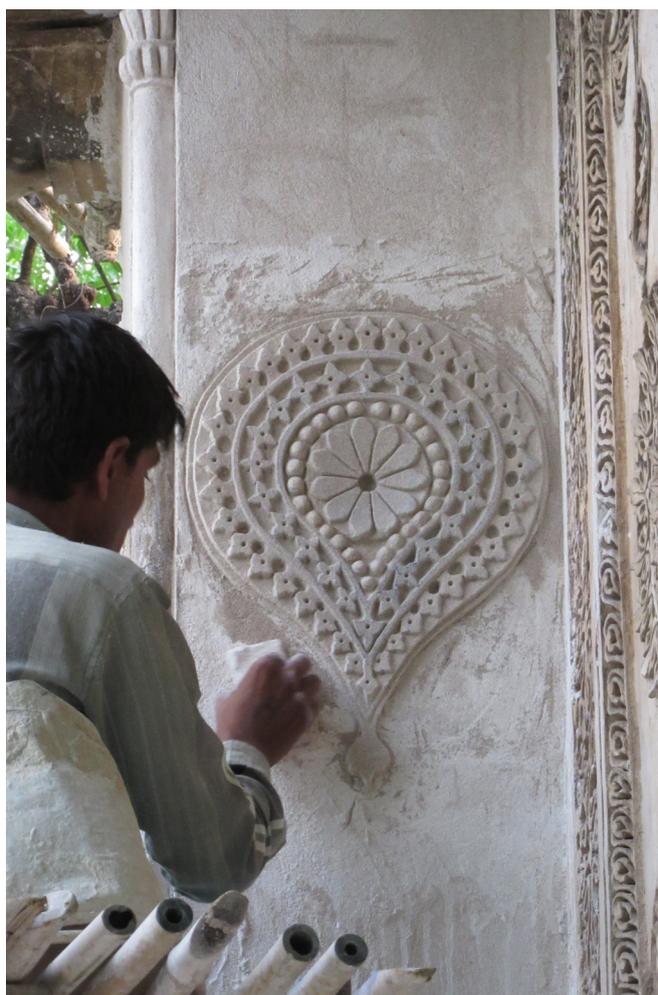
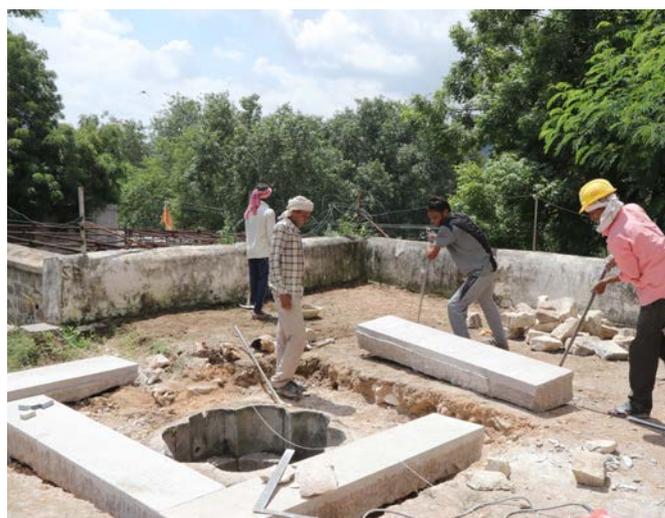
(Left) Restoration of lime stucco details on the facade; (Top Right) Installation of granite stone edging around the 'wazu'tank; (Bottom Right) Installation of hand chiseled dressed stone steps

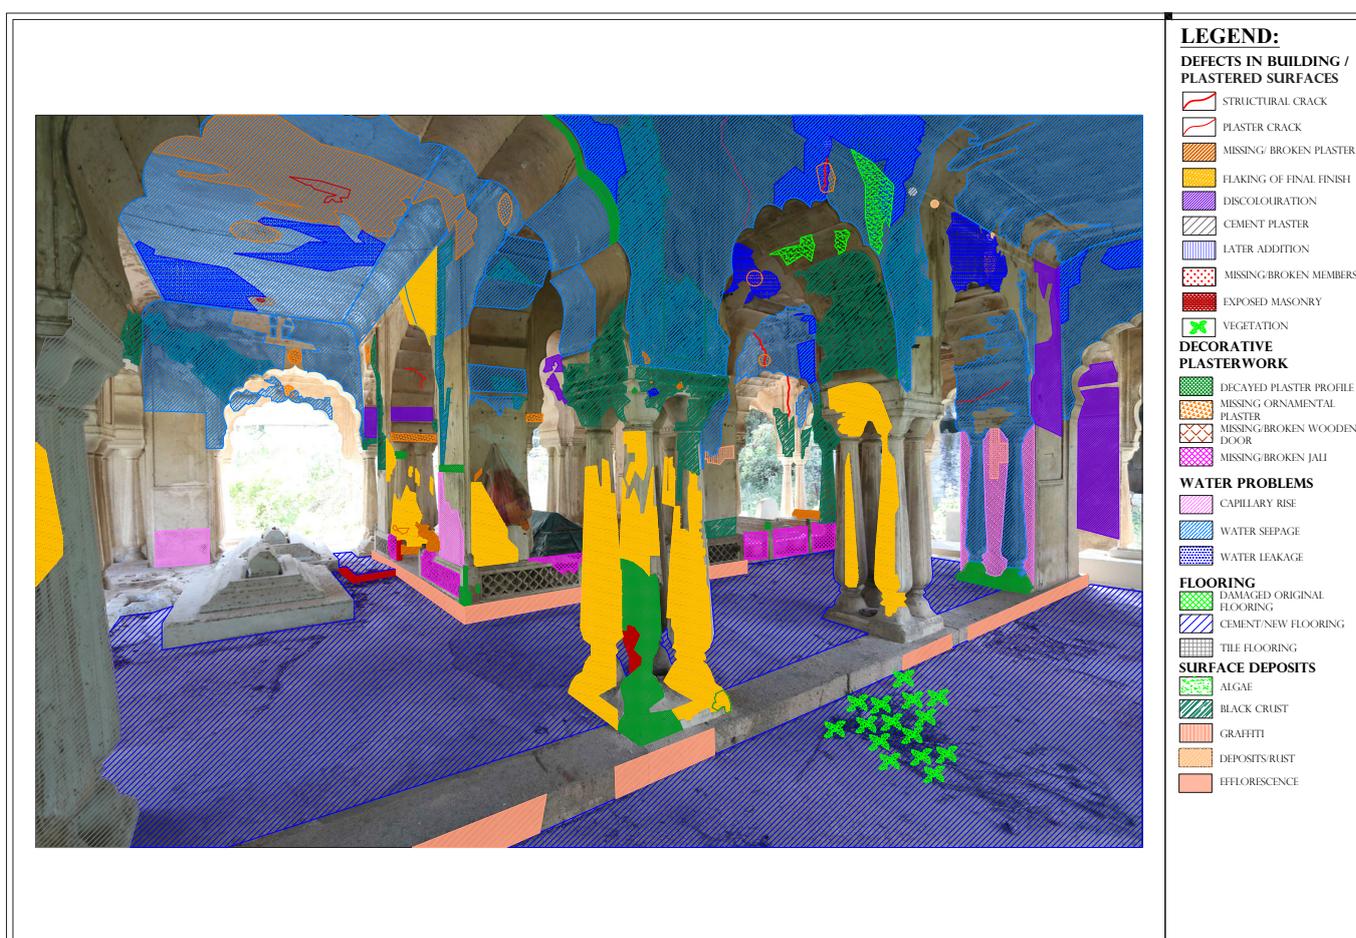
Condition assesment of Mausoleum of Ghansimiyan

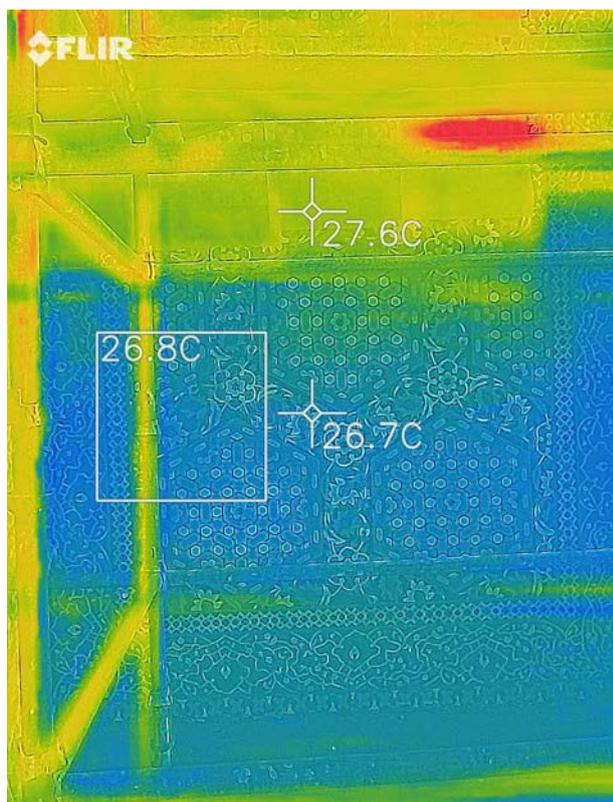
Thermal imaging using a thermal sensing camera, which helps detect areas of moisture. These readings will be taken over a course of a year at different seasons to understand impact of moisture/dampness on the tiles.

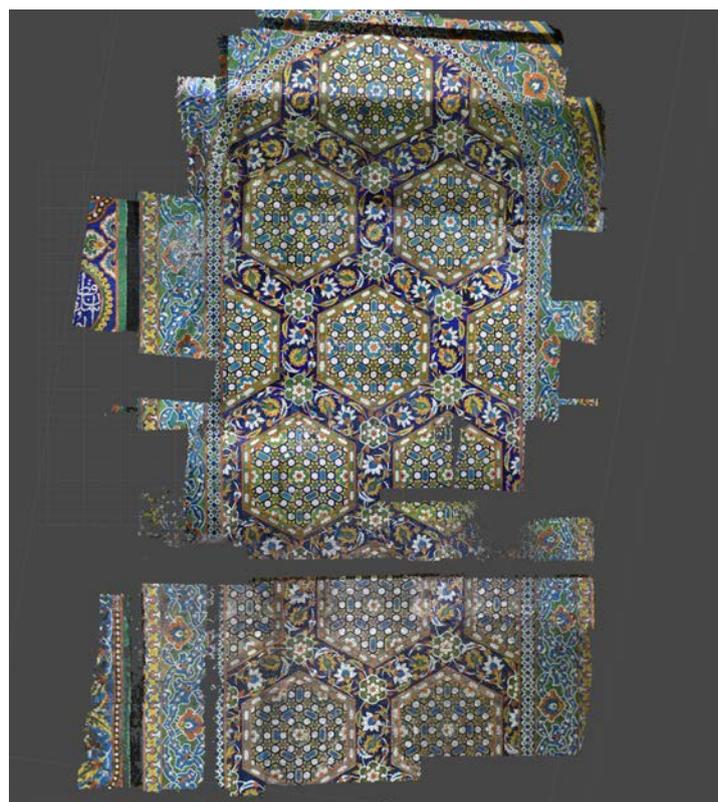
Photogrammetry is a scientific process documenting and taking measurements using a series of photographs. This helps build 3-d Models, 3 D point clouds and accurate measuring. The series of photos have been stitched together using a special software.
